CREATOR SCAFFOLD DESIGN AND UKSSH PROUD TO BE PART OF AN INNOVATIVE SOLUTION AT SELLAFIELD.

GASSE STUDY

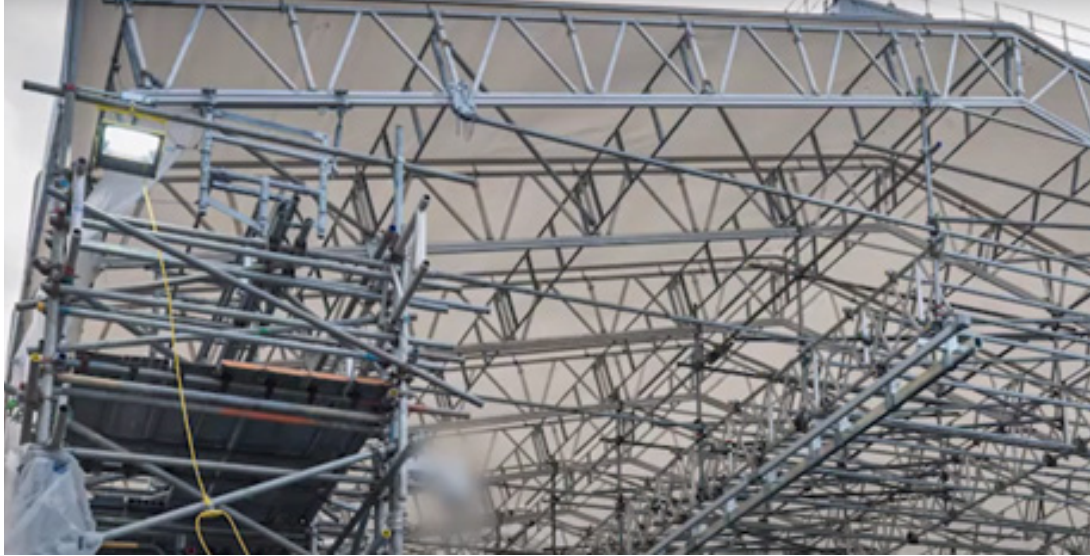
Working closely with Creator Scaffold Design, UKSSH supplied a Haki Temporary Roof that enabled a redundant sixty-year-old settling tank at Sellafield to be cleared of radioactive sludge and then be resealed in record time.

Clay Pickworth of Creator Scaffold Design explains that the rolling aspect of the roof was critical to the success of the project: "By designing a rolling roof we enabled scaffolders to build the structure from a position of relative safety and push it out over the tank – the alternative (traditional) approach would have required scaffolders to work over an open tank of radioactive liquor".

The primary requirement was to perform waste retrieval operations at a safe distance for humans while minimising any airborne contamination. The HAKITEC 750 Roof System from UK System Scaffold Hire was the perfect solution: Lightweight, safe, fast and easy to erect, the HAKITEC 750's highly effective weatherproof seal provides maximum protection against the elements and helps to contain hazardous materials.

The temporary roof enabled a gantry to be built above the tank which supported a remotely operated crane which lowered the necessary tooling to safely remove radioactive sludge and waste before re-concreting the base of the tank to reseal it.
